Unfilled Nail Hole Repair

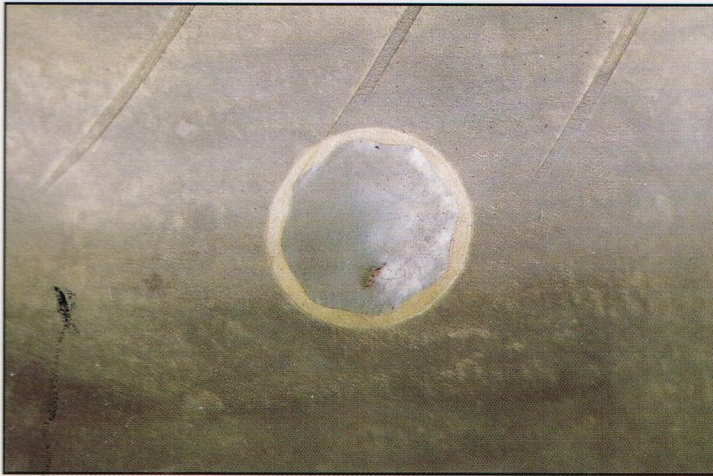
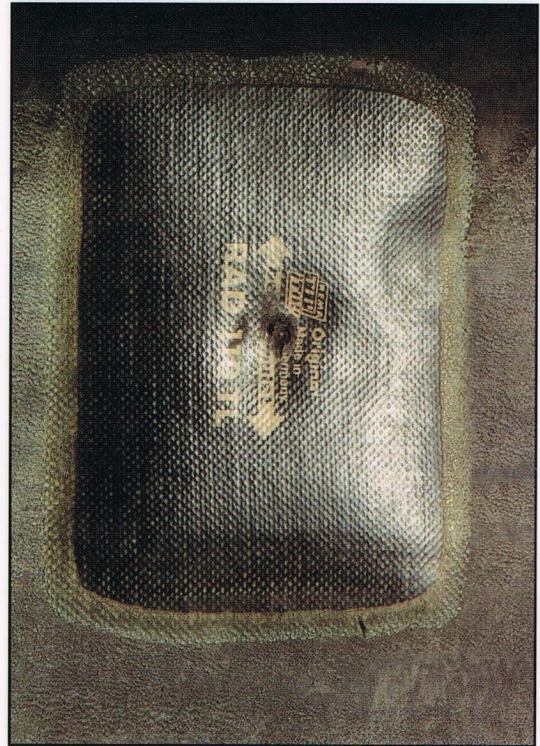
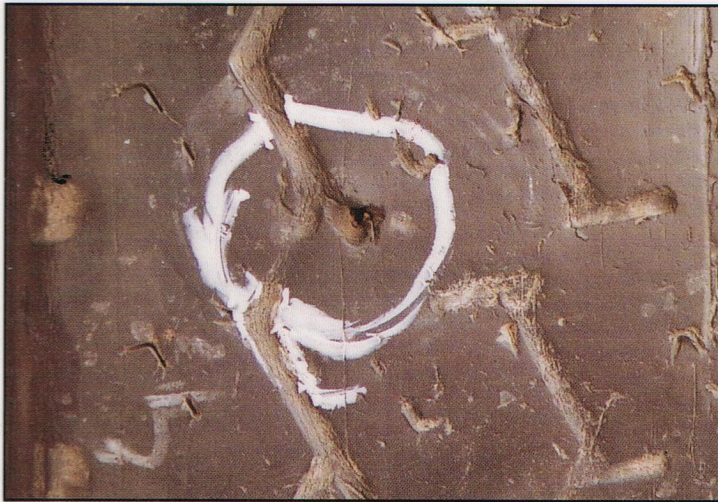
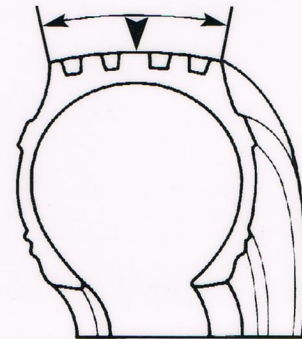
EXAMPLE PHOTO & FIGURE

Interior: The repair unit is dimpled or cracked. **Exterior:** Rust is evident in the unfilled hole.

The injury was not filled with a plug or rubber fill material.

Consult your retreader/repair person for possible warranty adjustment. Re-repair if possible, otherwise scrap the tire.

Review repair requirements with road service vendors and monitor on the road tire service.
